The results of the inspection of the structures of the extension to the public building in Lutsk

Drobyshynets S.Y., Ph.D. in Engineering, Associate Professor, Uzhehova O.A., Ph.D. in Engineering, Associate Professor, Bondarskyi O.G., Ph.D. in Engineering, Associate Professor, Uzhehov S.O., Ph.D. in Engineering, Associate Professor, Rotko S.V., Ph.D. in Engineering, Associate Professor, Deneychuk V.E., graduate student (Lutsk National Technical University, Lutsk)

The Construction Research Laboratory at the Department of Construction and Civil Engineering of Lutsk National Technical University inspected the extension to the public building (certificate of compliance No. 106-04/2023, dated December 22, 2023).

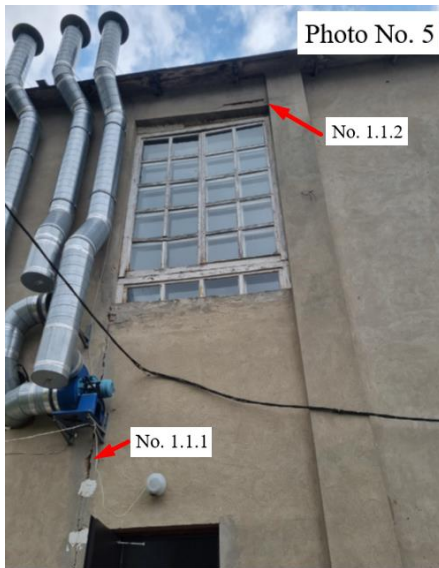
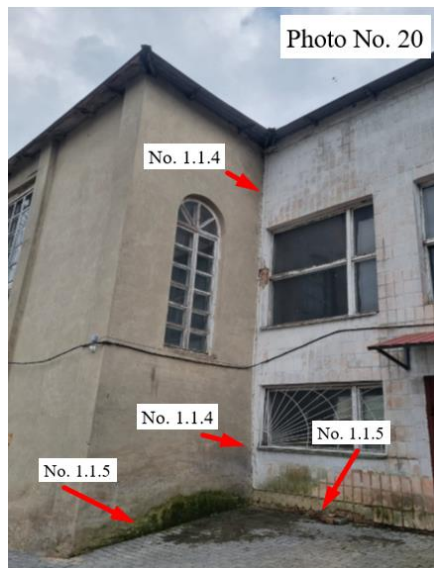
1.1.1.	Through crack with an opening up to 10 mm, axis 8, along the entire height	Photos No. 1-5, 8, 9, 12, 13, 19	Reinforcement with metal ties along the perimeter of the extension (in accordance with the developed reinforcement design project)

1.1.2.	Cracks above the window in axes 8-7	Photos No. 1-3, 5-7	Seal the cracks with M100 cement mortar
1.1.3.	Dampness in the lower part of the wall, fungal mold, and plaster peeling in axes 6-9	Photos No. 2-4, 10, 11, 13, 14, 19	Remove fungal mold using chemical and physical methods. Perform localized repair of the finishing layer

Fig. 1. Cracks (*a*, *b*) and dampness (*b*) on the outer side of the walls

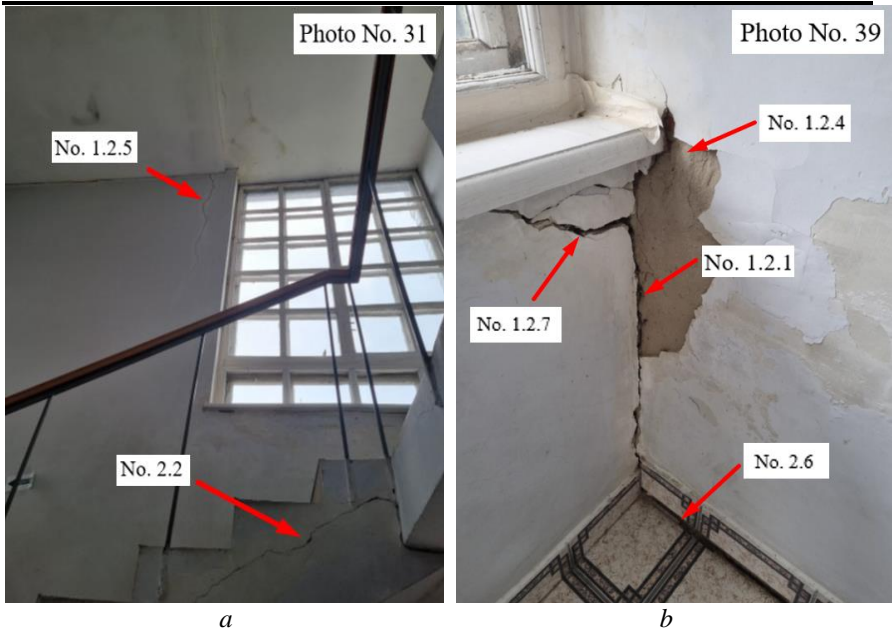
2.2.	Cracks along the stringer	Photos No. 24, 31	Reinforce the stair flight (in accordance with the developed reinforcement project) or completely dismantle the existing stair flight

2.6.	Subsidence of the stair landing by 35 mm	Photos No. 37-39	Reinforce the stair flight (in accordance with the developed reinforcement project) or completely

Fig. 2. Cracks along the stringer (a), subsidence of the stair landing (b)

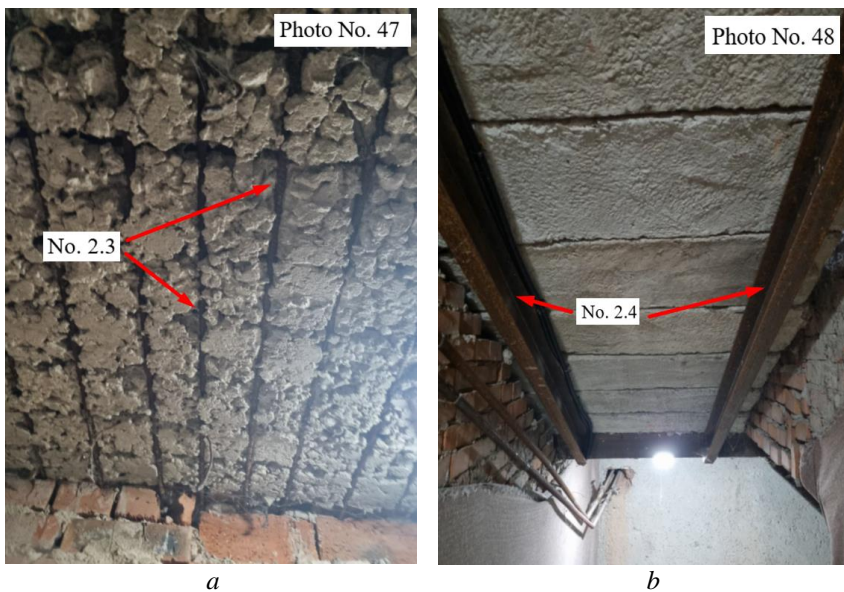
2.3.	Absence of the protective layer on the monolithic slab of the basement ceiling, reinforcement corrosion in axes 6-7, A-B	Photos No. 45-47	Clean the structural and working reinforcement from corrosion using mechanical and chemical methods, apply anti-corrosion protection, and restore the protective concrete layer over the structural and working reinforcement

2.4.	Corrosion of metal structures	Photos No. 48-49, 57, 58	Clean the metal structures from corrosion using mechanical and chemical methods, and apply anti-corrosion protection

Fig. 3. Corrosion of reinforcement (a) and metal structures (b)

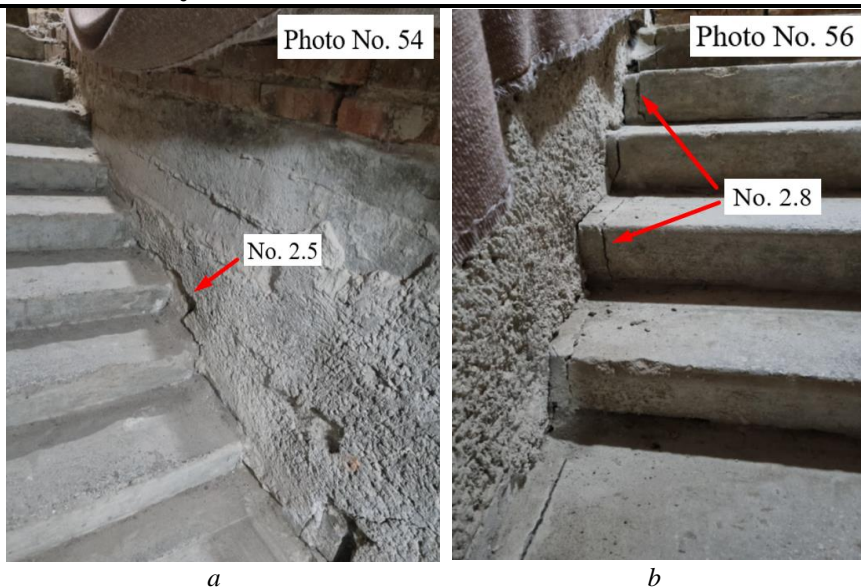
2.5.	Cracks at the basement entrance (foundation structure)	Photos No. 51, 52, 54, 55	Seal the cracks with M100 cement mortar, install gypsum gauges, and monitor. Subsequently, reinforce according to the developed reinforcement project

Fig. 4. Cracks in the foundation (a) and in the stair flights (b)
