**RELIABILITY OPERATING PROVIDING OF THE ROAD
CONSTRUCTION BY DETERMINING THE ACTUAL ELASTIC
MODULUS**

Fursovych M.A., PhD, senior teacher, Suprunyuk V.V., PhD, senior teacher, Ziatyuk Y.Y., PhD, senior teacher, Chepurko I.A. student (National University of Water and Environmental Engineering, Rivne)

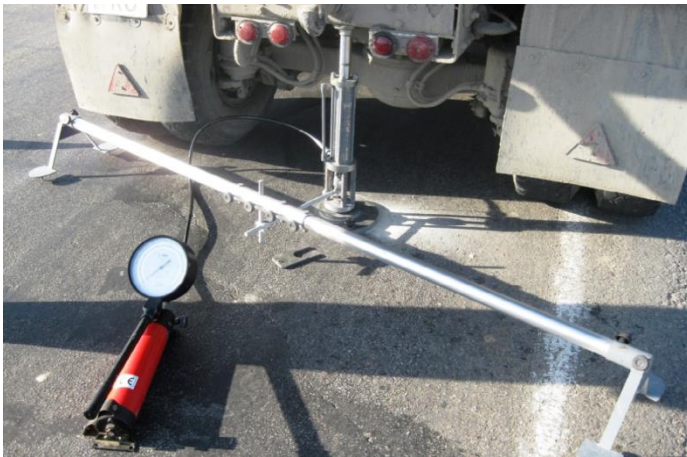
Loads on the surface of the tested structure are transmitted through a round rigid stamp with a jack resting on the frame of the loaded car (Fig. 1.). The load on the stamp is measured using a dynamometer built into the jack. The vertical movement of the stamp is fixed by the movement indicator of the clock type, the measuring rod of which is installed in the center of the stamp. In this case, the jack on the three support struts is installed on the stamp. The indicators are securely fastened to the rigid rail.

Fig. 1. Type of testing of pavement by stamping method device 35-T0116 / C "CONTROLS"

The load during the test is applied in levels to the maximum calculated value of 0.5 MPa; in total there should be not less than 3 - 6 levels. Load holding time - 60 s, pauses after unloading - 60 s, for loading and unloading - 20 - 30 s.

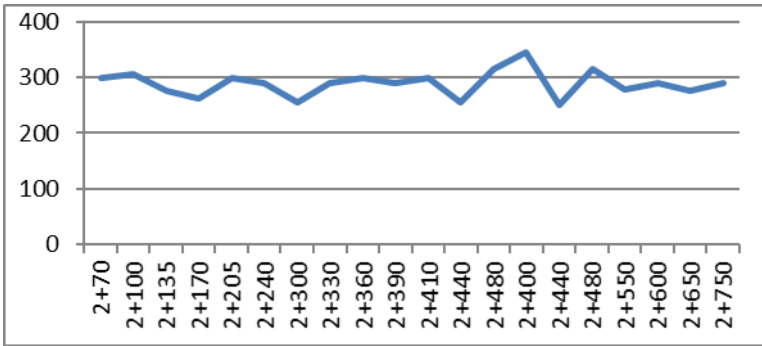
Fig. 2. Change of the modulus of elasticity of road pavement on the study area № 1

The research results - the modulus of elasticity of the soil or material in a homogeneous structure, as well as the total modulus of elasticity of the layered structure, tested by loads with a rigid stamp, are calculated by the formula:

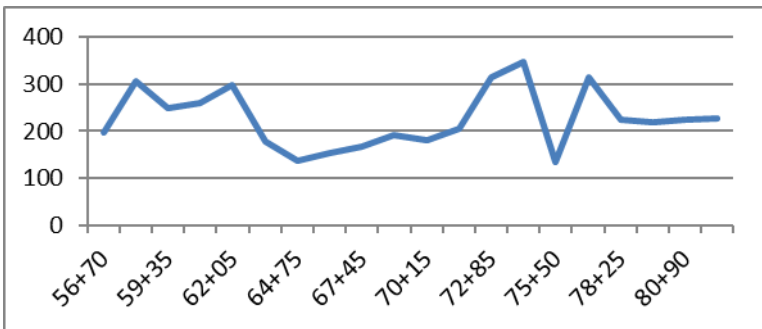
Fig. 3. Change of the modulus of elasticity of road pavement on the study area № 2

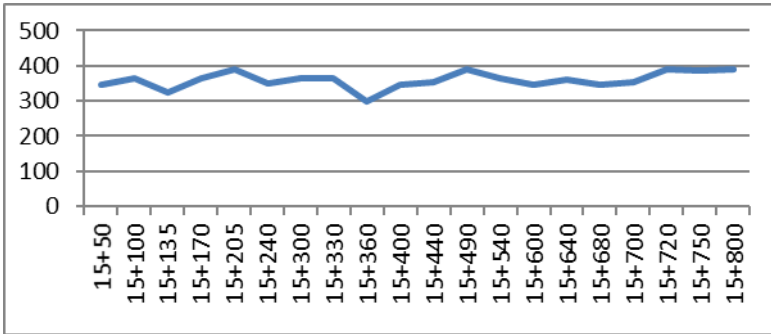
Fig. 4. Change of the modulus of elasticity of road pavement on the study area № 3

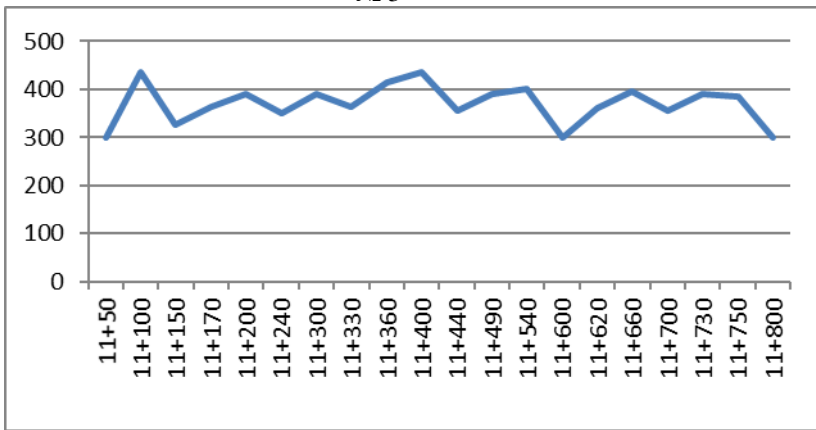
Fig. 5. Change of the modulus of elasticity of road pavement on the study area № 4
